VENTILATION RETROFIT CASE STUDY REDUCING AND BALANCING EXHAUST VENTILATION FLOW

BUILDING CHARACTERISTICS

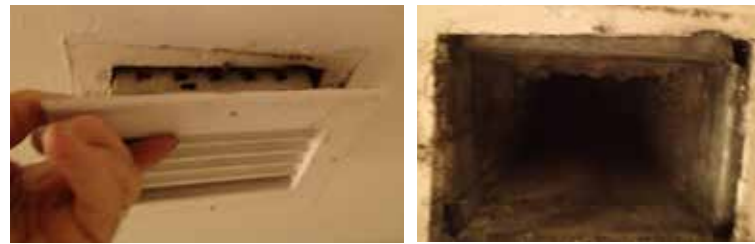
Figure 9: Before installation. Air leakage often found around the duct where it meets the sealing is important to seal.

Balancing distribution. A fixed, non-adjustable balancing plate with a properly sized orifice was added behind both the kitchen and bath inlets to help provide the desired inlet flow rate for a specified shaft pressure, barring any excessive duct leakage. A round orifice is easier to clean and less prone to clogging (Figure 10) than other commonly specified balancing devices, such as a balancing louver or constant air regulator. In addition, they are only 25% of the cost of the other devices. Based on the existing shaft pressure and the measured amount of shaft air leakage, we designed for a fan inlet pressure of 0.25 in wc (62.5 Pa) with bathroom and kitchen orifice diameters of 2.0" and 2.1" to produce exhaust flow rates of 25cfm for the bathrooms and 30cfm for the kitchens. In order to access the kitchen duct, the contractor removed and reinstalled the range hood motor and fan. This increased the labor costs, but allowed the work to be completed without disturbing the asbestos duct wrap.

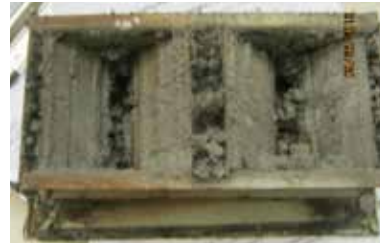
Figure 10: Clogged balance louvers.

There were some units that were under-ventilated and others that were over-ventilated, with measured flow rates ranging from no flow to 6 times the required flow. The kitchen shafts had the greatest opportunity for energy savings with 70% of kitchen inlets over-ventilating. In addition, 13% of the inlets had no flow, most often because some of the exhaust hoods had an integrated back draft damper that was stuck shut. This was less of an issue with bath inlets, of which 10% had no flow and 4% were over-ventilating. In some cases the balancing louvers directly behind the bath inlet grilles were either clogged with dust or had been altered at some point to change the flow (louver adjustability permits tampering, and slight alterations can affect the entire shaft).

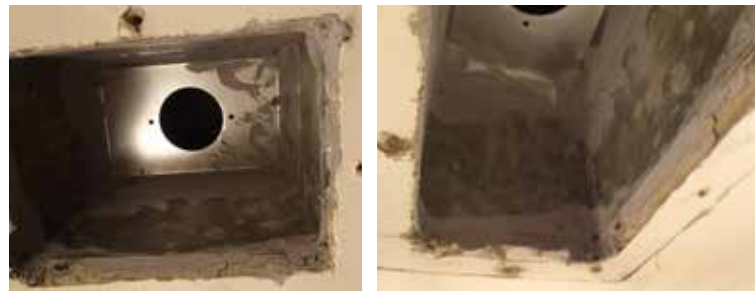
Figure 11: Left image - new fixed inlet orifices installed. Right image - register grilles were removed, the old balancing louvers were detached and discarded, the new balancing orifices were installed, and mastic sealant was applied to any leakage around the orifice and at the ceiling connection.

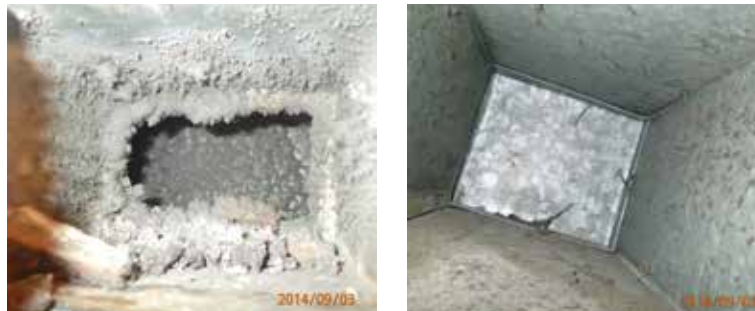
Figure 12: Branch ducts at bath inlets before and after cleaning. Branch duct inlets were cleaned before the new balancing orifices were installed.

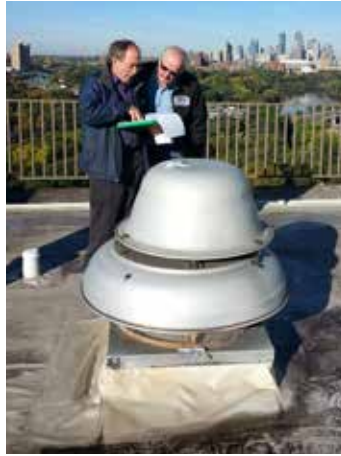
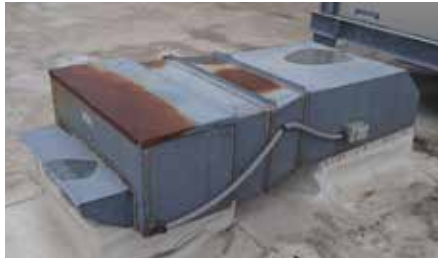
Figure 3.1 & 3.2: Exhaust PRVs on rooftop. Large PRVs on the roof provide exhaust flows ranging from 850 to 1,850 cfm. One PRV had an unusual termination cap that required modifications to our flow capture boxes.

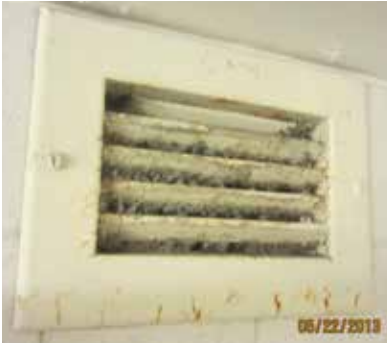
The property management regularly responded to odor complaints due to either clogged inlets or broken drive belts on aging rooftop fans. A total of 30 inlets were clogged or otherwise non-operable. In other units, high ventilation airflow contributed to a feeling of draftiness.

Partially clogged bath inlet fan.

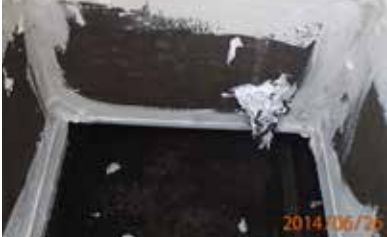
Mastic applied to curb below PRV fan to provide an airtight connection between ventilation shaft and fan.

For the above reasons, the building management chose to replace the existing fans with ones that have properly sized ECM motors and speed controls. The electricity savings for the fan upgrades reduced the fan power use by 2/3, yielding a 7 year payback. Our work scope included sealing air leakage at the transition between the fan and the shaft at the roof curb, which is often a leaky connection. It was a minimal issue for this project, but is a concern worth addressing on any project where the curb is accessible.

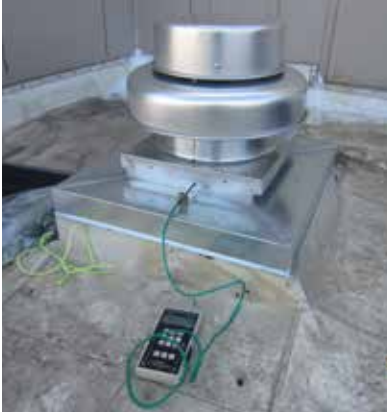
Figure 8: Upgraded PRV fans are much smaller. We are preparing to measure the post-retrofit PRV flow ensure its within +/-10% of the flow requirement.

After all of the orifices were installed and the fans replaced (Figures 8, 9, 10 & 11), we adjusted the fan speeds to achieve the specified shaft pressures, measured the PRV flows, and measured the flow rate for a sample of inlets to make sure both inlet and outlet flows were within +/-20% of the code requirement.
