ENERGY SAVINGS ANALYSIS

VENTILATION RETROFIT CASE STUDY
REDUCING SUPPLY VENTILATION FLOW

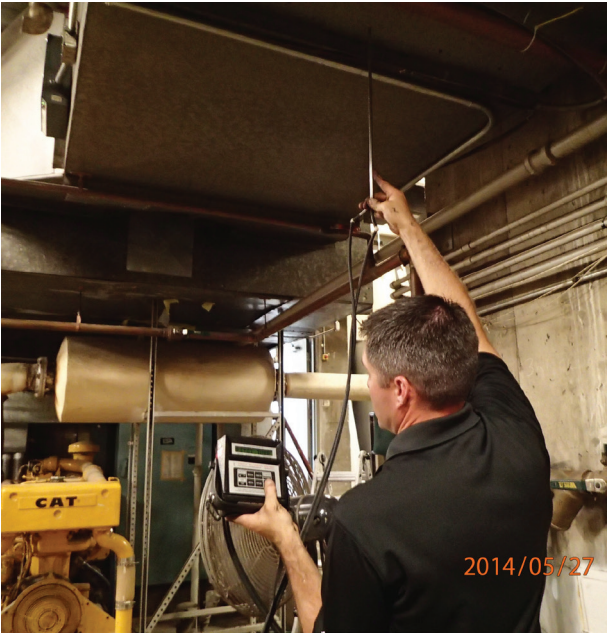
Figure 8: Test and balance contractor measuring airflow before and after fan turn down.

Serving as owner’s representatives for the property, we wrote a work scope describing the adjustment and desired outcome and obtained bids for the work from three Test and Balance (TAB) crews. The bids ranged from \$1,200 to \$2,746 and the low bid was selected. The work scope was to re-sheave the corridor fan and confirm airflow within +/- 10% of the required flow (ASHRAE 62.1-2007, Section 8.4.1.8, specifies +/- 10% balancing tolerance). This would pay back in 2 months. The work scope did not include balancing distribution to all registers, but if included, paybacks would still have been less than 6 months. Figure 8 shows the TAB contractor measuring make up airflow by completing a duct traverse.

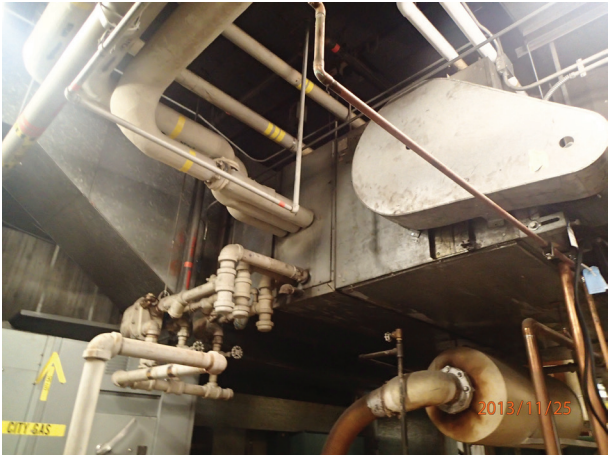
SUPPLY SYSTEM. Outdoor air is continuously supplied to the corridors on floors 2 through 22 by an air handling unit that is located in the basement (Figure 1). It draws 100% fresh air, with no recirculated air. The outdoor air intake for this air handling unit is an 84 x 108 inch grille located at the rear wall of the first floor exterior (Figure 2). It draws in outdoor air and filters, conditions and distributes it through a common vertical shaft to a single register on each floor (Figure 3). The typical hallway layout for the building is shown in Figure 4. A second air handling unit supplies outdoor air mixed with return air for the main floor and basement community areas. A third air handling unit located in the penthouse serves the community area on the 23rd floor. The building is conditioned with steam boilers in winter and individual apartment unit window A/C cooling during summer. Each air handling unit has a heat exchange coil from the boilers to condition outside air. For this study, only the corridor air handling unit was evaluated. The air handling units serving the common areas on the 1st and 23rd floors were not within the scope of this study and are not discussed in this case study.

Figure 1: Corridor supply air handling unit

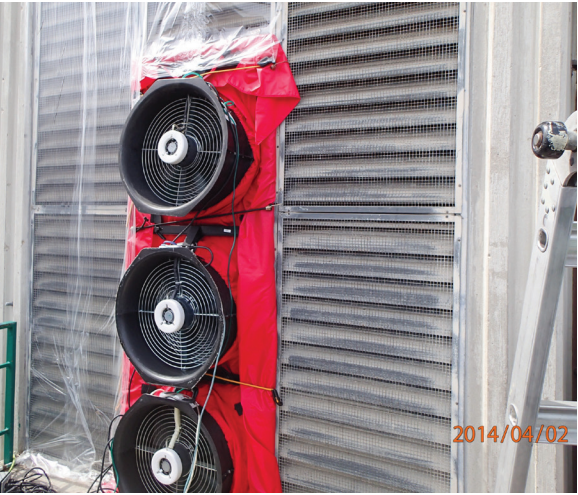
We measured the total outdoor air intake airflow of corridor supply using a blower door, masked to cover the entire intake opening and adjusted to measure flow while matching the existing duct pressure (Figure 5). We found that reducing the supply ventilation flow rates could achieve significant energy savings with paybacks well under one year.

Local code officials require a corridor make up airflow rate of 6,905 cubic feet per minute (cfm) to match apartment exhaust airflow (instead of the ASHRAE 62.1 requirement of 852 cfm). The air handler was providing 11,745 cfm of make up air, 70% more outdoor air than is required.

Figure 5: Airflow measurement. Crew used a calibrated fan to measure outdoor air intake airflow.

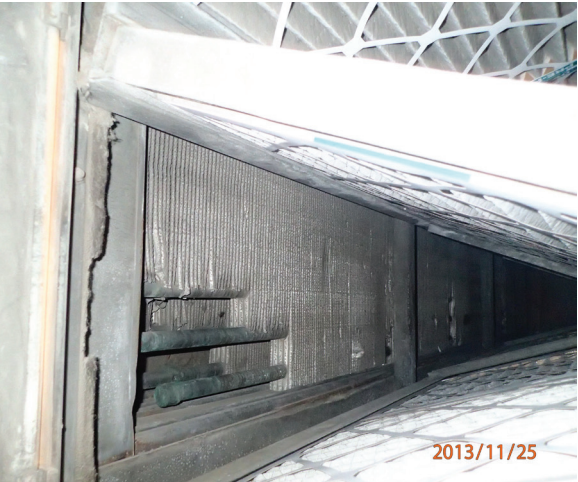
At the time of the assessment the heat exchange coil downstream of the filters was loaded with dust (Figure 6). While the filter was clean, the access door for the filters had a broken hinge which was allowing air to bypass the filters and move directly into the heat exchange coil without dust filtration. This clogged up the coil and restricted airflow. Since the initial airflow measurement number would change once the coil was cleaned, we recommended another airflow measurement be taken after the coil was cleaned, but before it was adjusted to reduce flow. With the clogged coil, the airflow was 3,700 cfm above the flow requirement. After the coil was cleaned, the airflow rate increased 1,100 cfm, which was 4,800 cfm above the flow requirement

Figure 6: Dirty heat exchange coil restricted airflow. Air was bypassing the filters (right side) because of a broken hinge on the filter access door and dust was accumulating in the heating coil in the air handler, affecting heating efficiency and restricting airflow.

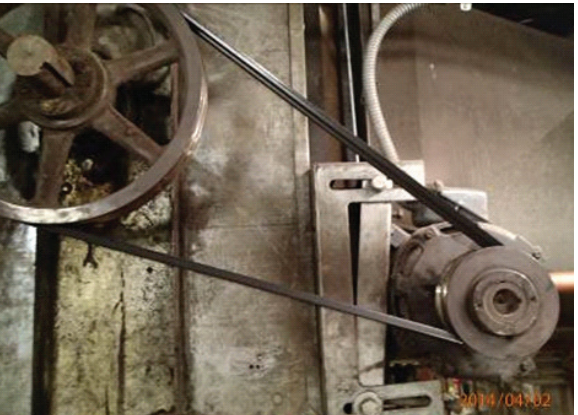
Figure 7: Corridor fan pulleys.

There were two options for reducing flow on the corridor air handling unit. The first option was to re-sheave, or change the pulley size on the existing fan, to reduce fan RPM. A second option was to add a variable frequency drive (VFD) to the fan to equip fan turndown. Figure 7 shows the fan motor and pulleys. Adding a VFD to the fan had higher upfront costs and, though it could be fine-tuned to accurately meet desired flow rates, the digital control is easy to tamper with and flow can be altered with the turn of a dial. VFD controls are also not compatible with all motors. Compared to the fluid adjustment capability of the VFD, re-sheaving would achieve tiered changes to RPM and would have a broader margin of error for achieving targeted flows. However, re-sheaving is a low cost, permanent change to the fan RPM that is widely accepted in the industry. For these reasons we chose to re-sheave the existing fan.
