VENTILATION RETROFIT CASE STUDY REDUCING AND BALANCING EXHAUST VENTILATION FLOW

BUILDING CHARACTERISTICS

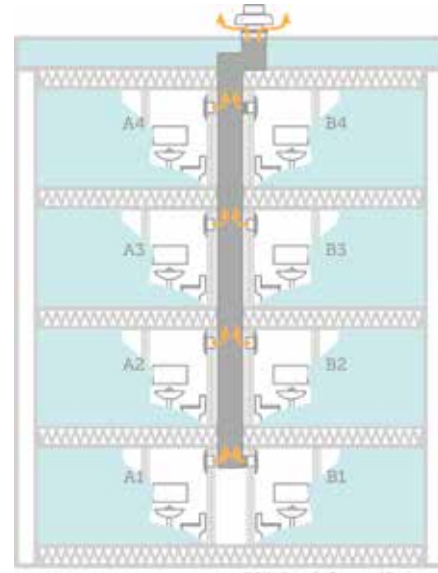
Figure 1: Exhaust system configuration. 10 PRV fans serve the building, 6 shafts for bathrooms and 4 shafts for kitchens.

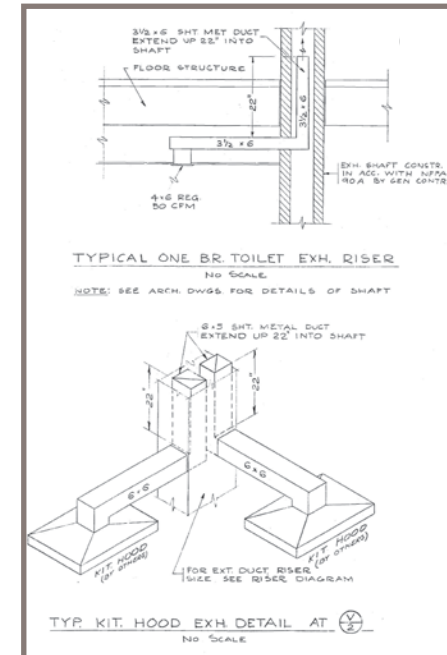
Figure 2: Blue prints showing exhaust inlets and subducts into shaft.

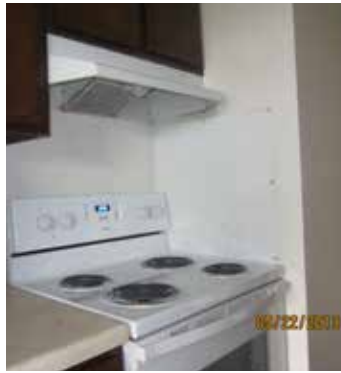
Figure 4: Kitchen exhaust inlets. The exhaust hood over the stove is connected to a continuous PRV fan. It can also be switched on at the exhaust hood to boost already high flows to double or triple their rates.

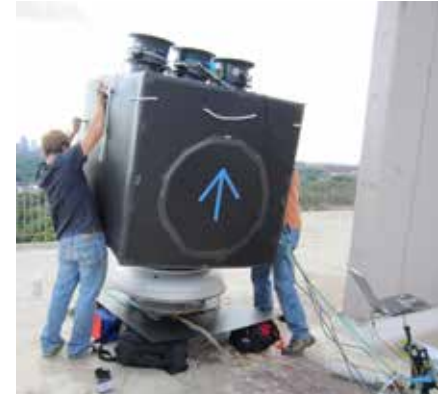
Significant energy savings opportunity for reducing exhaust ventilation. We measured the total exhaust airflow of each PRV to determine the energy savings potential of the exhaust system. We used a collapsible capture cube (Figure 5) set over each PRV. The cube was fitted with Duct Blaster fans that measured flow when the fan speeds were adjusted to match the pressure in the PRV shaft during normal operation. We found a potential for reducing and balancing exhaust flow rates by 50%, which would achieve significant energy savings with total project paybacks less than 6.5 years.

Figure 5: A collapsible capture cube fitted with 3 Duct Blaster fans was set over exhaust fans on the roof, measuring flow when the pressure in the cube matched the shaft pressure. A comparison of the total flow of all inlets on a shaft to the outlet flow for that shaft gave an indication of the amount of duct system leakage.

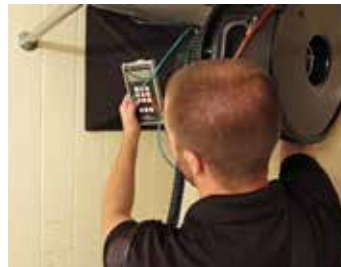
Significant ventilation improvement opportunity for balancing ventilation distribution. We measured all exhaust inlet flows and compared them to the intended flow for each apartment. We used the FlowBlaster adapter for the Duct Blaster fan (Figures 6 & 7), which accurately measures inlet flow on a multi-inlet system by using the Duct Blaster fan to compensate for the capture hood adapter flow restriction. Once we obtained all inlet measurements we compared the total PRV outlet flow to the measured inlet flow to compute the amount of air leakage in the duct boots, branch ducts and shafts.

Figure 6: Bath inlet measurement. The FlowBlaster adapter for the DuctBlaster fan, measures inlet flow accurately on central exhaust systems by utilizing the calibrated DuctBlaster to compensate for pressure drop from the capture hood.

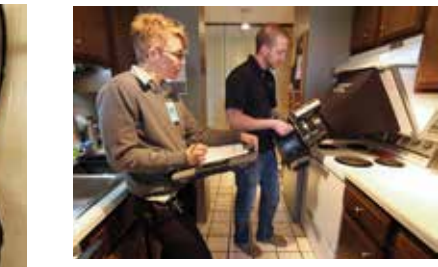
Figure 7: Kitchen inlet measurement. A triangular capture box was constructed so that the FlowBlaster could measure the kitchen range hood flow.
