ENERGY SAVINGS ANALYSIS

VENTILATION RETROFIT CASE STUDY
REDUCING SUPPLY VENTILATION FLOW

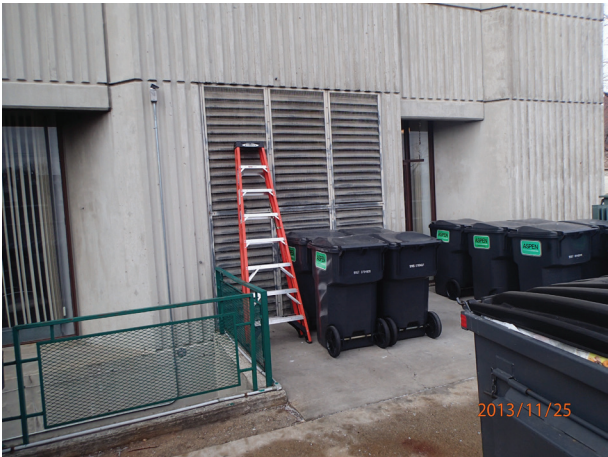
Figure 2: Air intake for corridor air handling unit

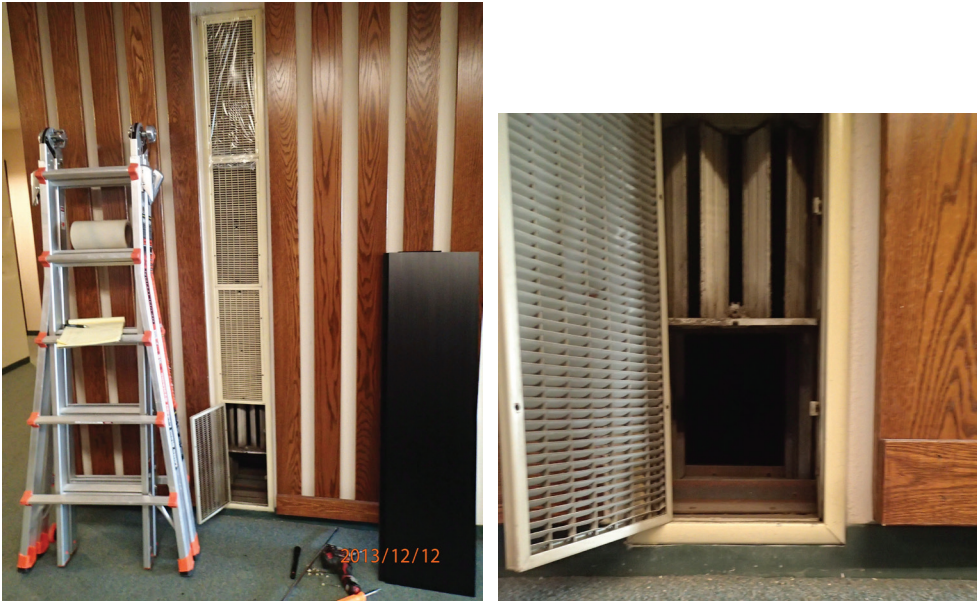
Figure 3: Corridor registers. Left: A single 8”x80” register supplies make up supply air to each floor’s corridor. Right: The balancing damper behind the register grille provides airflow adjustment.

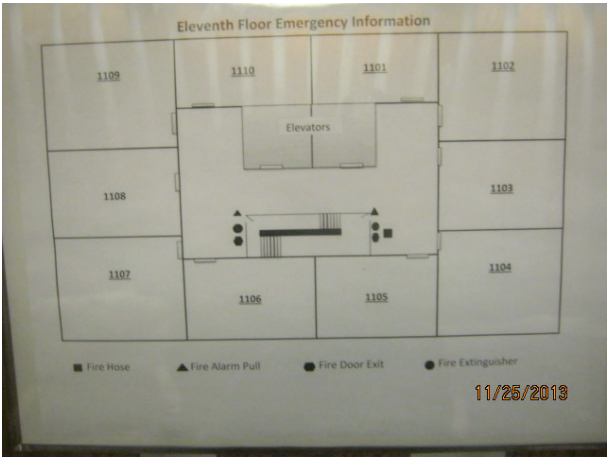
Figure 4: Fire escape plan posted in the hallway shows typical floor layout. There are 10 units per floor around the perimeter of the building and minimal corridor area in the center of the building. One supply register provides 100% outdoor air to make up for air exhausted from apartment units.
